**N.J. NO NAME DAM  
NO. 40**

**NJ 00208**

**PHASE 1 INSPECTION REPORT  
NATIONAL DAM SAFETY PROGRAM**

4. TITLE (and Subtitle) Phase I Inspection Report National Dam Safety Program NJ No Name Dam No. 40 NJ00208 Passaic County, New Jersey		5. TYPE OF REPORT & PERIOD COVERED  FINAL

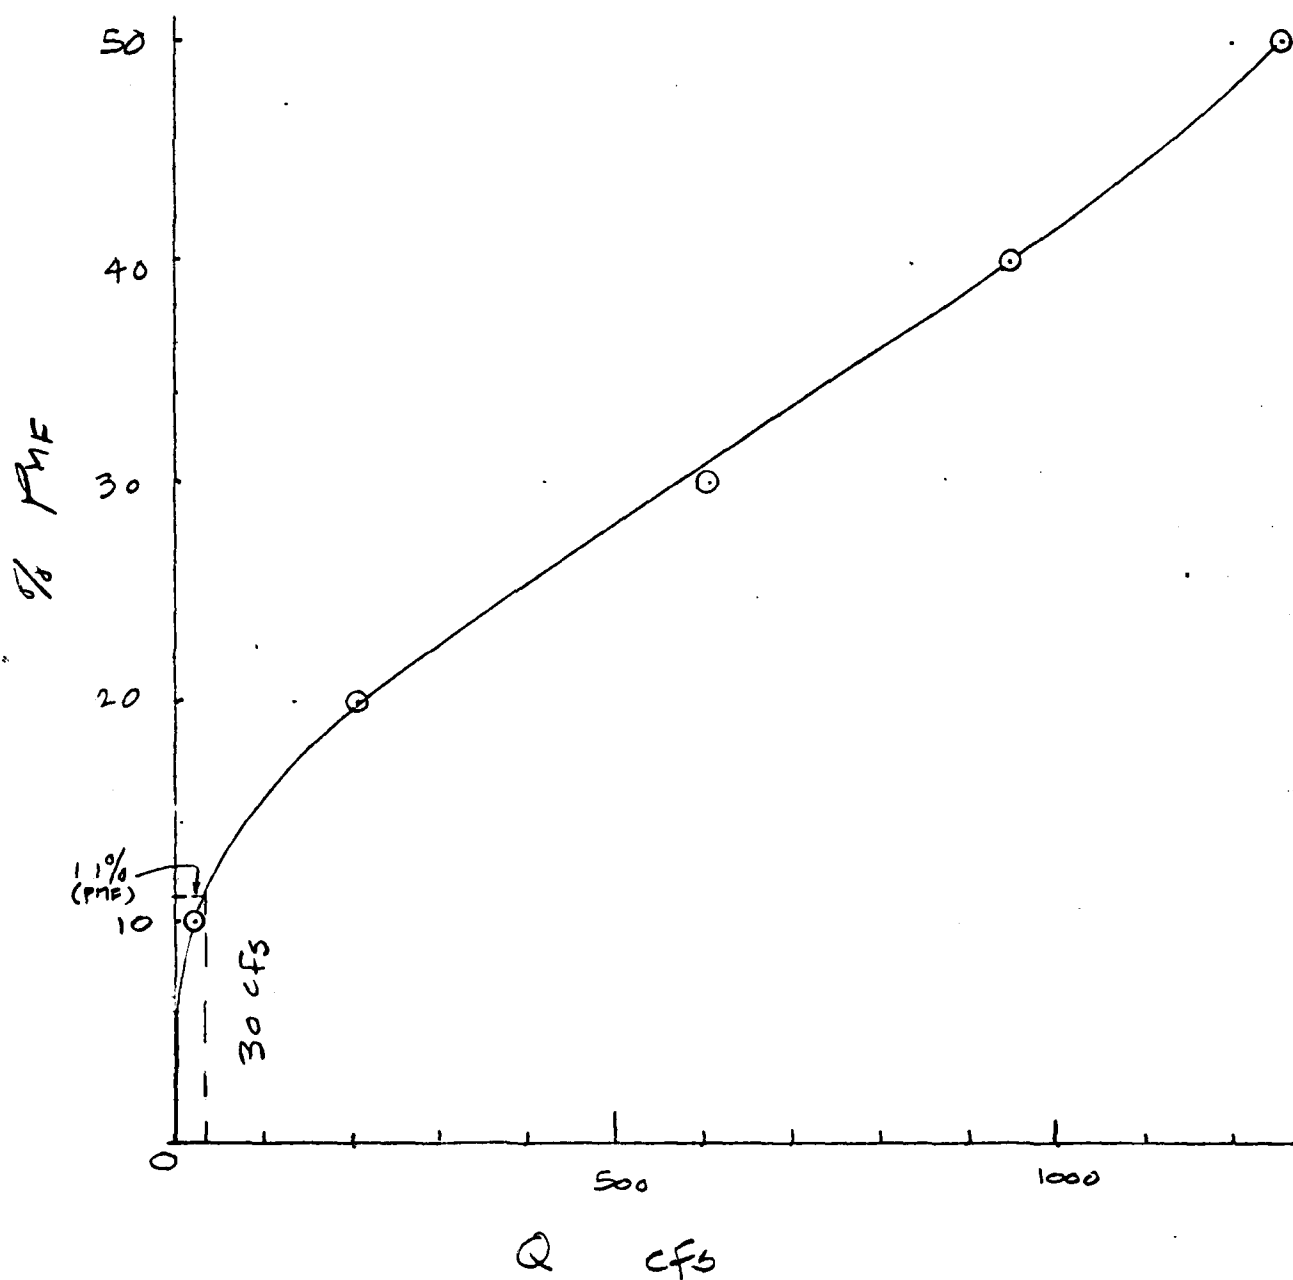
Overtopping Potential

Overtopping of Dam occurs at Elev. 960 with  $Q = 30$  cfs ( $\sim 11\%$  PMF)

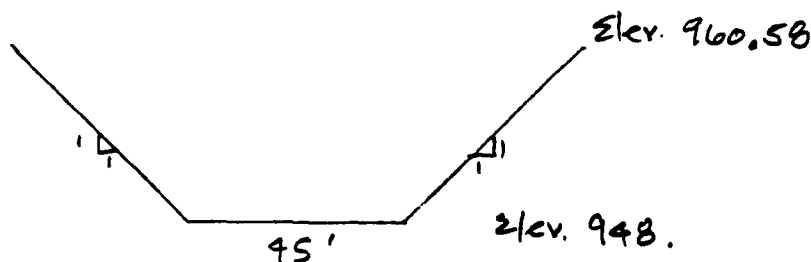
### Breach Analysis

Based on Sensitivity analysis, the breach begins to develop when Lake stage to reach Elev. 960.58 at 20% PMF with fail time = 0.5 hr.
